Natural Conditions Assessment for Low pH and Low Dissolved Oxygen, Monquin Creek and Tributaries in King William County, Virginia

**Submitted by
Virginia Department of Environmental Quality**

January 2012

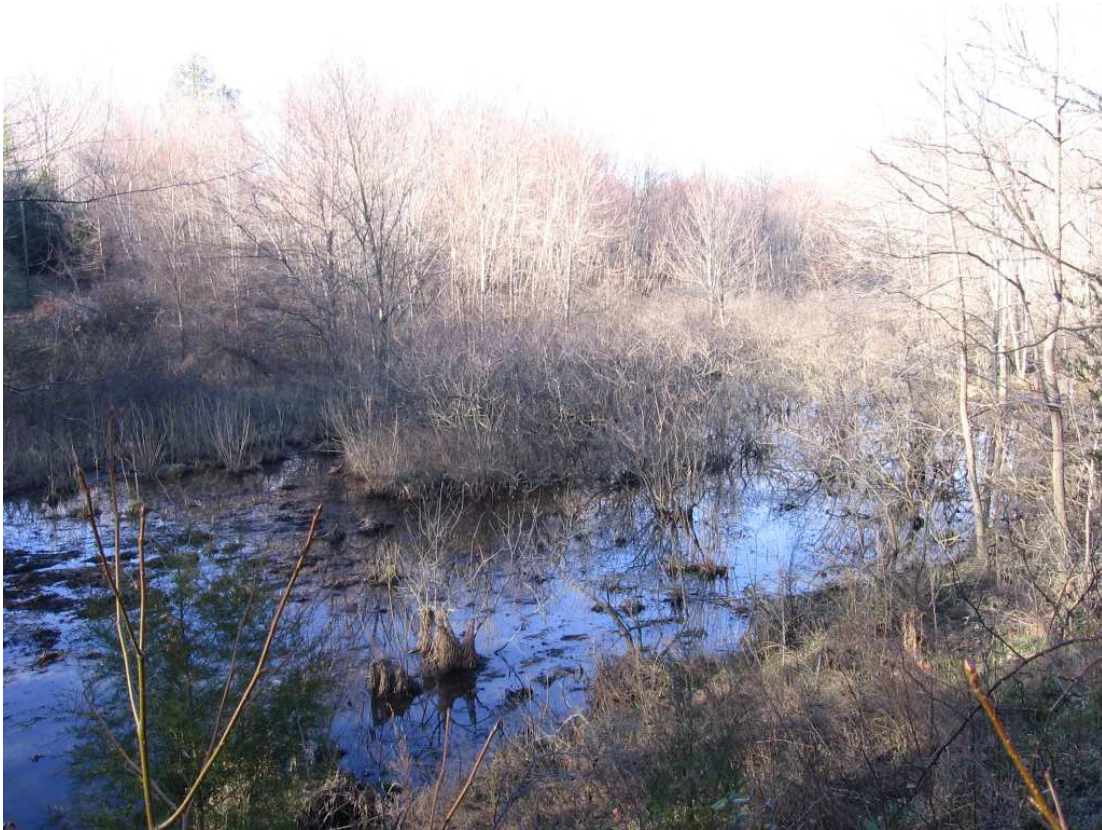
Figure 10. Monquin Creek, Rt. 360 Upstream.

Visual inspection of Monquin Creek and tributaries revealed swampy areas with heavy tree canopy. Decomposition of vegetative matter from large swampy areas lowers DO and pH as decay occurs. (Figures 10 - 12).

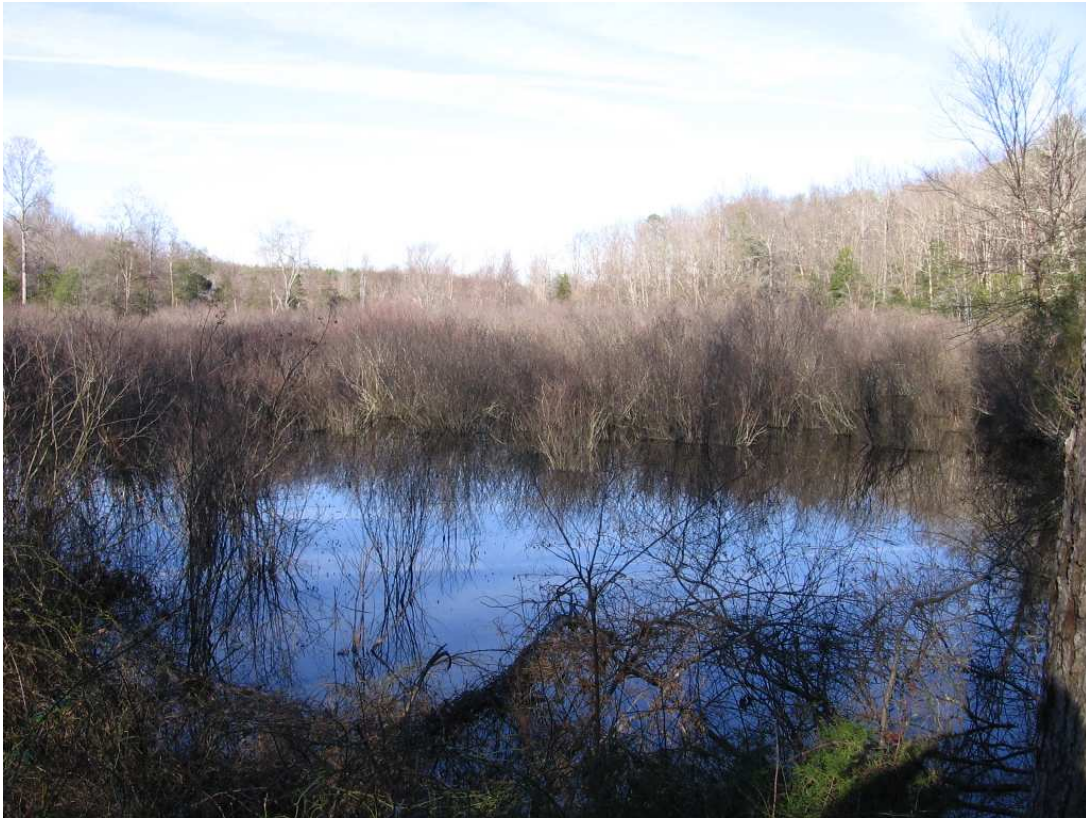
Figure 11. Governor Creek, North of Rt. 1203, Upstream.

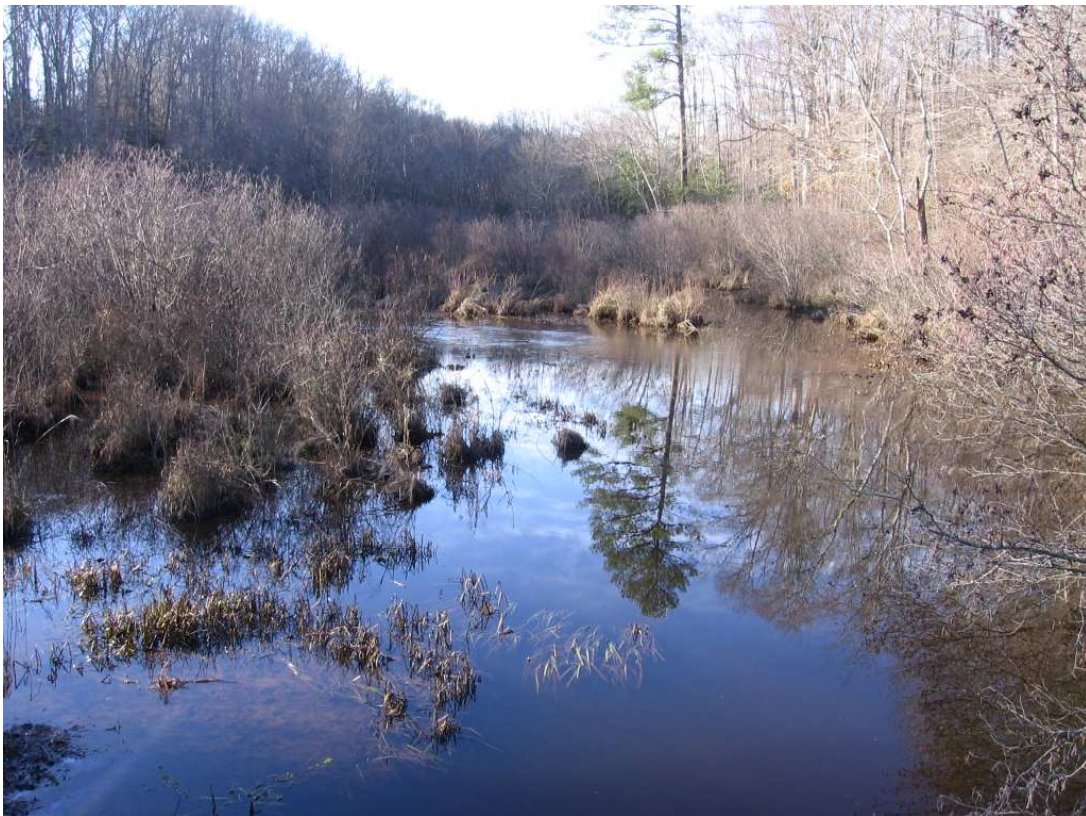
Figure 12. Webb Creek at Rt. 610, Upstream.
